Troubleshooting Passive Intermodulation Problems in the Field

By Nicholas Cannon

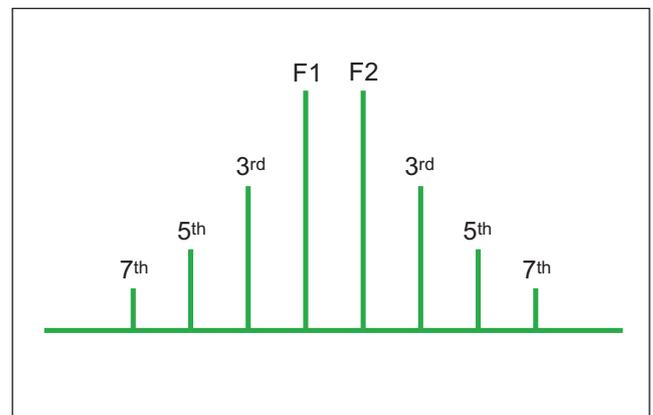
Figure 1. Carriers F1 and F2 with 3rd through 7th order products.

F1 and F2 are carrier frequencies and the constants n and m are positive integers. When referring to PIM products, the sum of $n + m$ is called the product order, so if m is 2 and n is 1, the result ($2+1=3$) is referred to as a third order product. Typically, the third order product is the strongest, causing the most harm, followed by the fifth and seventh order products, which also cause significant harm. Because PIM amplitude becomes lower as the order increases, higher order products typically are not strong enough to cause direct frequency problems, but they usually assist in raising the adjacent noise floor.

A standard PIM test will almost always test for the 3rd order because it is almost always the most predictable. The actual problem that exists within a site, however, may actually be 5th or 7th order PIM products that are causing the degradation in site performance.

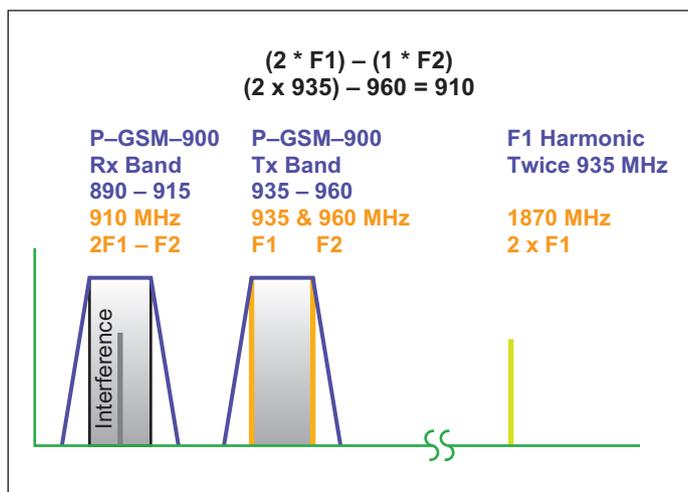
Figure 4. PIM causing receiver de-sense at 910 MHz.

A PIM example for the widely used 900 MHz band assumes two GSM carriers, one at 935 MHz, and the other at 960 MHz. In this case, the 910 MHz third order product is in the base station receive band.

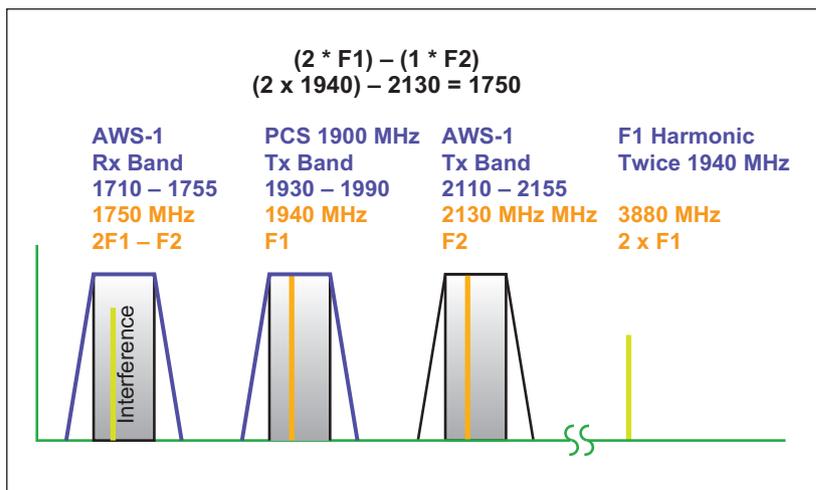
Figure 3. PIM causing receiver de-sense at 1710 MHz.

In the first example, 1750 MHz is one of the third order products and falls within the AWS-1 base station receive band. If the 1940 MHz and 2130 MHz carrier sources are physically close to each other, or even sharing the same antenna, any corrosion or other non-linear effect will generate a third order passive intermodulation product at 1710 MHz that can cause receive de-sense, or blocking. It is worth mentioning that PIM products do not need to fall directly on the uplink channel to cause problems. They only need to fall within the receiver's pre-filter, which is typically a full band component.
